VALIDATION OF STAMPER DEVICE TO MEASURE INTERNATIONAL ROUGHNESS INDEX IRI

TYPE: Research Article

Keywords: International Roughness Index (IRI), STAMPER, roughness index, quality of road surface.

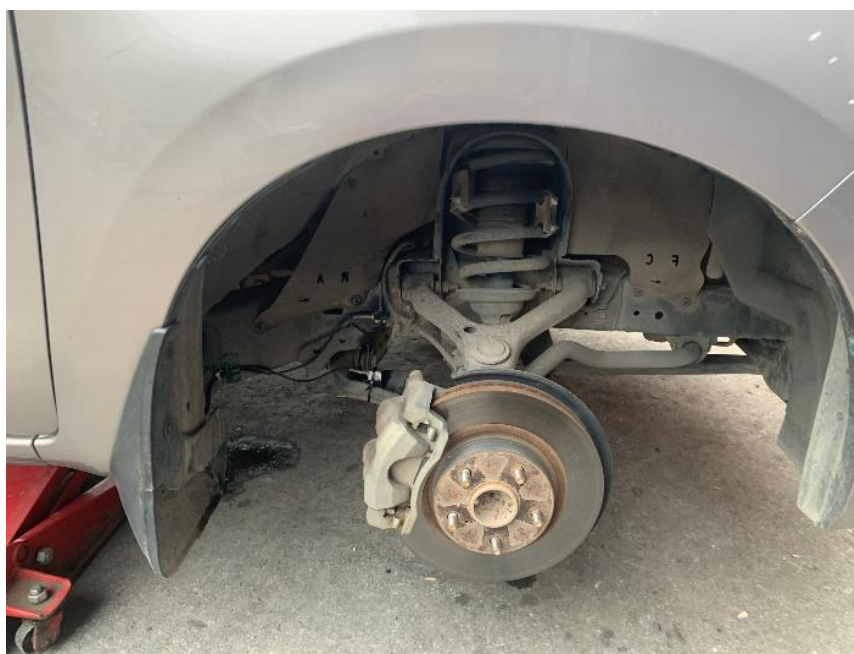
Figure 2. Install the devices: remove the wheel to install the accelerometers.

STAMPER device of Taisei Rotec company is installed on two vehicles to measure data according to the manufacturer's instructions, also including a GPS receiver, and a video camera [8]. Before measuring, the devices are installed, and parameters are determined.

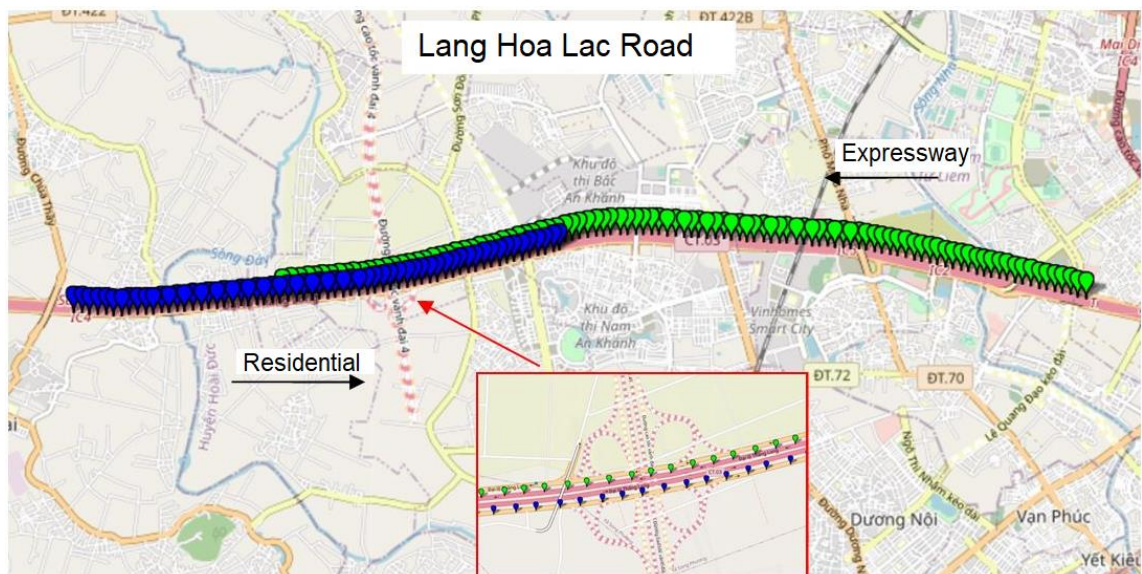
Figure 4. Measurement taken on Lang – Hoa Lac (Residential and Expressway): the map on GPSVisualizer with measurement data.

As shown in Figure 4. Measurement location of Lang - Hoa (Residential and Expressway), Figure 5. Measurement location of National Highway 5 (from Nhat Tan bridge to Dong Tru bridge), three types of roads around Ha Noi are measured, which are Expressway, Residential and National Highway. On these routes, there are many lanes, measurements are taken on the appropriate lane that the measuring vehicle can pass through, ensuring the vehicle maintains the required speed and runs in the selected lane. There are 3 measurement routes with a total of 4 lanes, and information about the measurement sections is shown in Table 2. Information on IRI measurement routes.

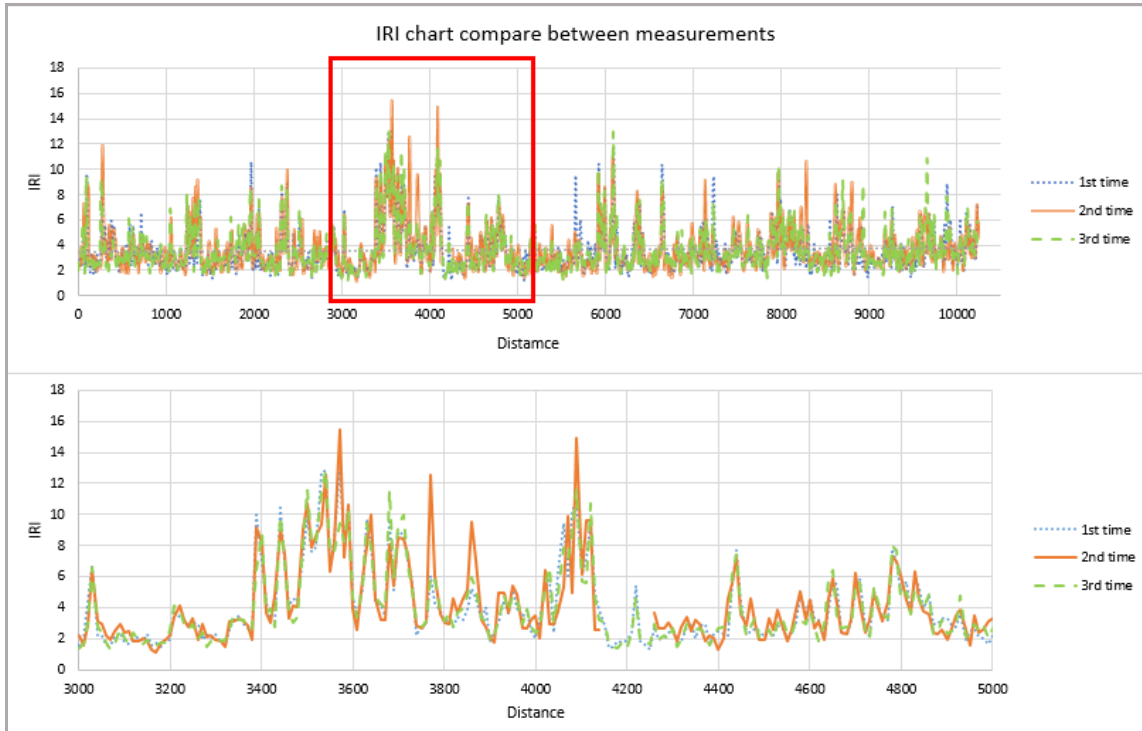
The measurement was taken place at Lang Hoa Lac expressway, at the speed of 40km/h, on the outer right lane as shown below. Average IRI results measured at three times is 3.55mm/m, 3.63mm/m and 3.61mm/m respectively. The ratio of the average value of the difference of IRI values between two measurements to the average IRI value can be used to consider the difference between two series of measured values of IRI, and is called the relative average Denta. This value of measurements 1-2 is 1.14%, between measurements 1-3 is 1.71%, between measurements is 2-3 is 0.56%. Thus, the deviation between repeated measurements with the same type of vehicle and the same speed is quite small and insignificant.

Figure 6. Comparison of IRI_{10m} value between 3 times on the Lang Hoa Lac Expressway.

At Lang Hoa Lac expressway and Lang Hoa Lac residential road, the IRI data obtained of these two routes are in two different ranges. But it can be seen that with same speed and vehicle, the measurements by STAMPER device have low relative average Delta. At Lang Hoa Lac expressway the results of Delta respectively are 1.14%, 1.17%, 0.56%, at Lang Hoa Lac residential route the results of Delta are 1.54%, 1.86%, 3.45%. This proves that the reliability level of the STAMPER device when repeatedly measuring is quite high with many types of roads and different IRI values.

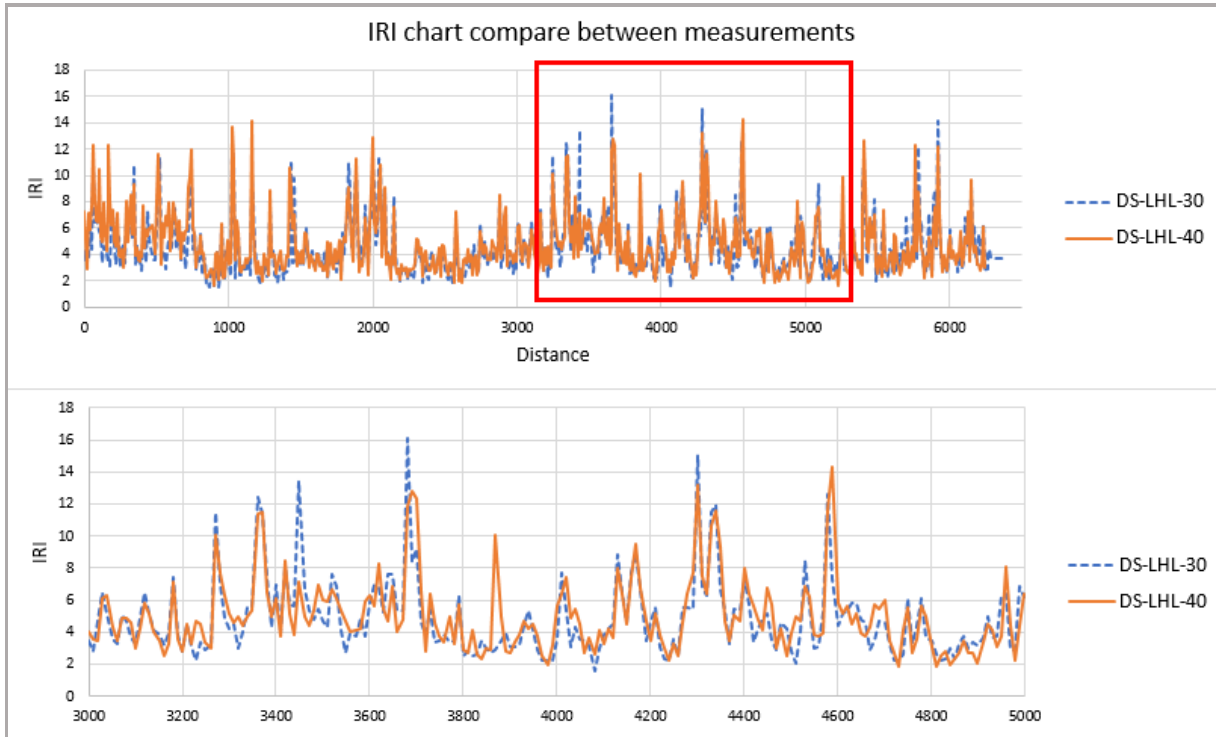
The measurement was taken place on Lang Hoa Lac residential road, using Kia Carens with two different speeds of 30km/h and 40km/h, the results are in the chart below. With IRI measured at a speed of 30km/h is 4.49mm/m and a speed of 40km/h is 4.77mm/m, the relative average Denta is equal to 5.8%. With this result, the value obtained of IRI when measured at a speed of 40km/h is higher than the value of IRI when measured at a speed of 30km/h. The relative average Denta value on the Lang Hoa Lac residential road (IRI = 4.88mm/m) is larger than that on the Lang Hoa Lac expressway (IRI = 3.60mm/m).

Figure 9. Comparison of IRI_{10m} value when measured at speeds of 30km/h and 40km/h on Lang Hoa Lac residential road.

Based on the measurement results of using the same vehicle, at different speeds and the same location on the Lang Hoa Lac expressway, Lang Hoa Lac residential road, and National Highway No.5, the measured IRI values are the same. The relative average Denta of expressway is 1.76%, residential roads is 5.8% and national highways is 1.68%. The IRI values are similar between measurements at different speeds on many types of roads, meaning that different speeds have a negligible effect on the IRI measurement results when using STAMPER.

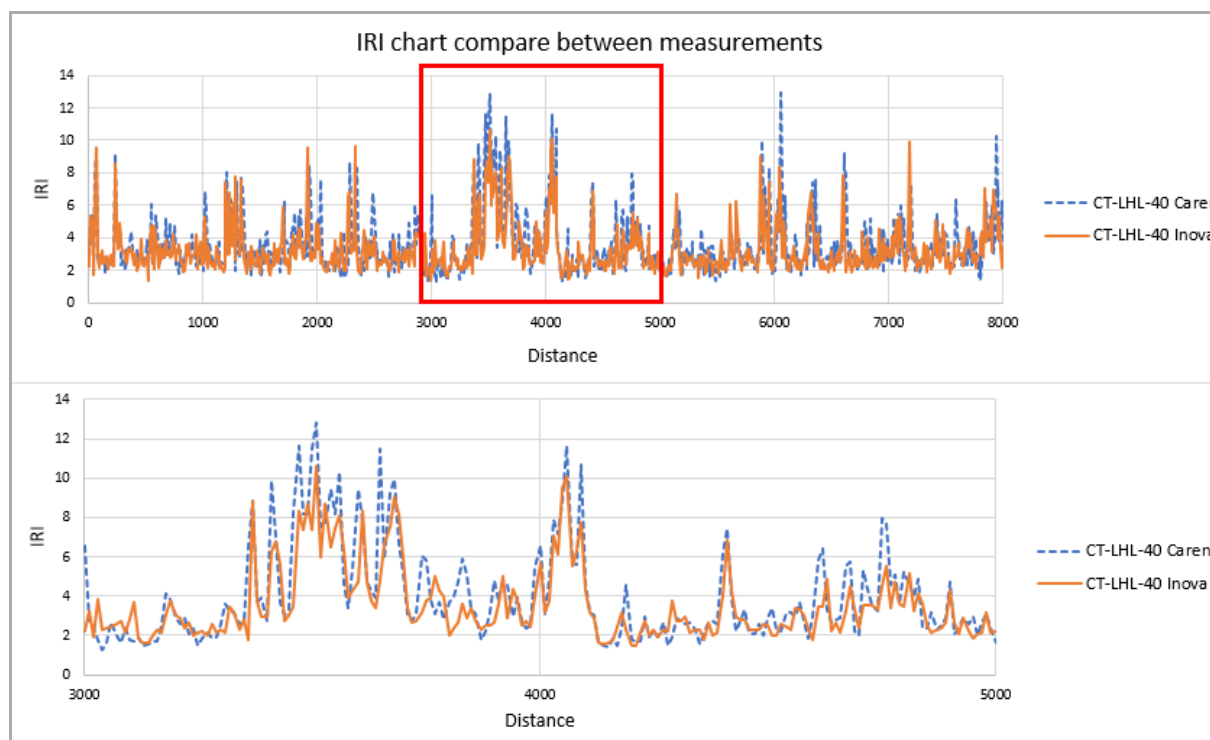
Figure 11. Comparison of IRI_{10m} value when measured with 2 types of vehicles on Lang Hoa Lac expressway.

Measurement results show that, on the Lang Hoa Lac expressway: at the same speed of 40km/h, when measured by Carens vehicle, $IRI=3.55$ mm/m is obtained, when measured by Innova vehicle, $IRI=3.28$ mm/m is obtained. Relative average delta is equal to 8.01%.

By the ability to be installed on many vehicles, in this case the research team used Kia Carens and Toyota Innova. IRI measurements using different cars show similar results in both trend and value. This result is very meaningful to evaluate the flexibility of the device. Being able to setup and use on many different types of vehicles helps improve the flexibility and convenience of use of STAMPER. This allows management agencies to survey road surface condition more easily by their existing vehicles with high speed and accuracy when they cannot use other high-cost specialized device.
